Recall Bulletin

PRODUCT SAFETY RECALL

SUBJECT: Shift Lever Indicator May Not Display Correct Gear

MODELS: 2008-2010 Chevrolet Malibu
2008-2010 Pontiac G6
2007-2010 Saturn AURA
Equipped with 4-Speed Automatic Transmission (ME7/MN5)

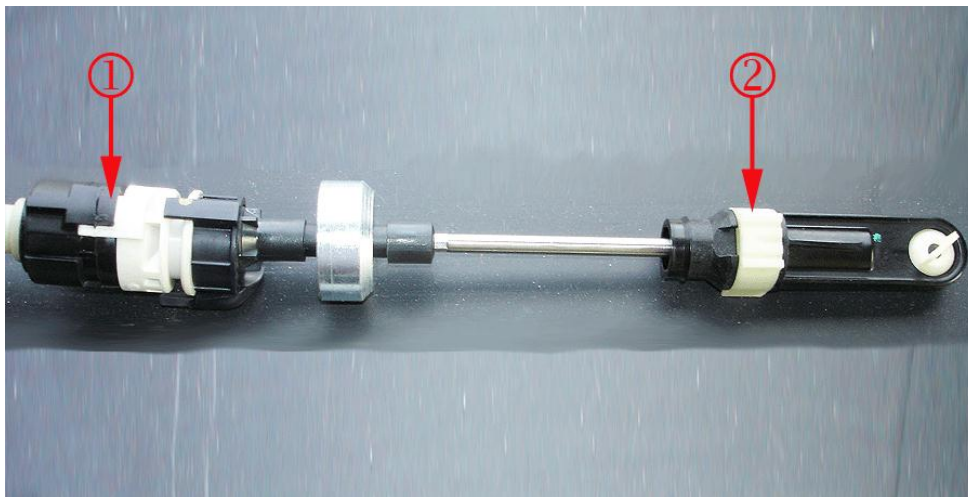
2269489

- (1) Shift Cable Locking Tabs
- (2) Shift Cable Adjuster Locking Clip
